Manhole Inspection Summary

Manhole # S04GG2017MH

Insp Date: **9/25/06 9:15 AM**

Location Address: **7007 BOXFORD RD**

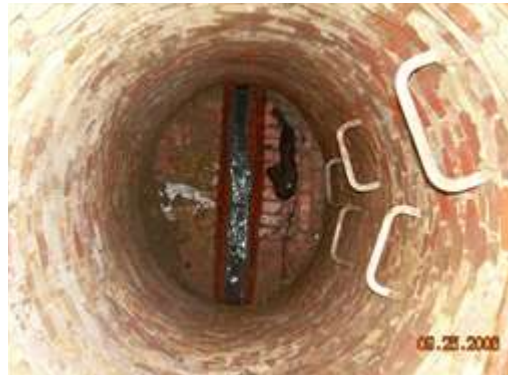
Top View

Adjustment and Barrel infiltration.
Evidence of surcharge - Bench debris.

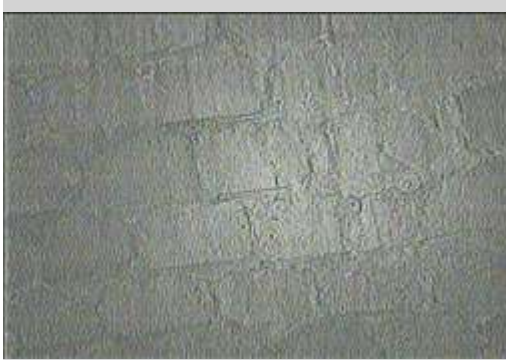
Defect

Condition: ☐ Sound ☐ Cracked ☐ Root Intrusion ☐ Loose Brick ☒ **Deteriorated**

Infiltration: ☐ None ☐ Joint ☐ Cracks ☒ **Mortar** ☐ Roots ☒ **Wall**

Barrel deterioration and infiltration.

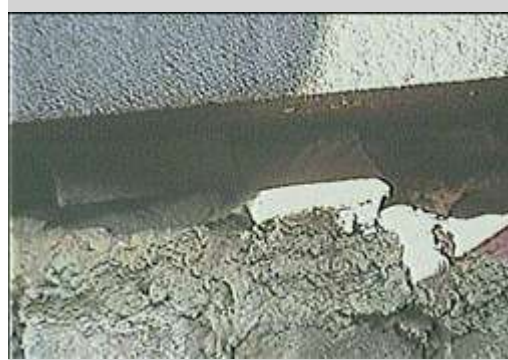
Defect

Frame Offset: **0** (in.) Condition: ☐ Sound ☐ Cracked ☒ **Leaks**

Condition: ☐ Sound ☐ Cracked ☐ Root Intrusion ☒ **Loose Brick** ☒ **Deteriorated**

Infiltration: ☐ None ☒ **Joint** ☐ Cracks ☒ **Mortar** ☐ Roots ☐ Wall

Frame leaks. Adjustment deterioration,
loose brick and infiltration.

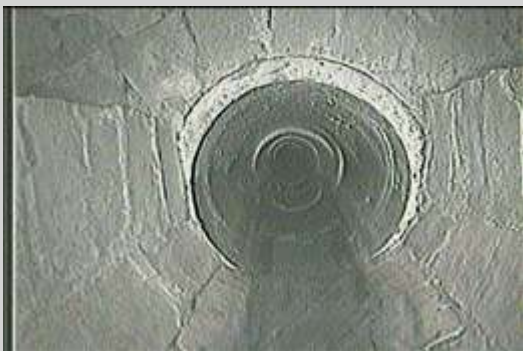
8 in. Circular Gravity Sewer Pipe In @ 6 O'Clock

Infiltration: **Evidence** Pipe Seal Cond: **Unknown**
